## INSPECTION DETAILS

PUMPER REPORT  
SEPTIC SYSTEM MAINTENANCE  
& PUMPING INFORMATION

Address: 21 Warbler Ln

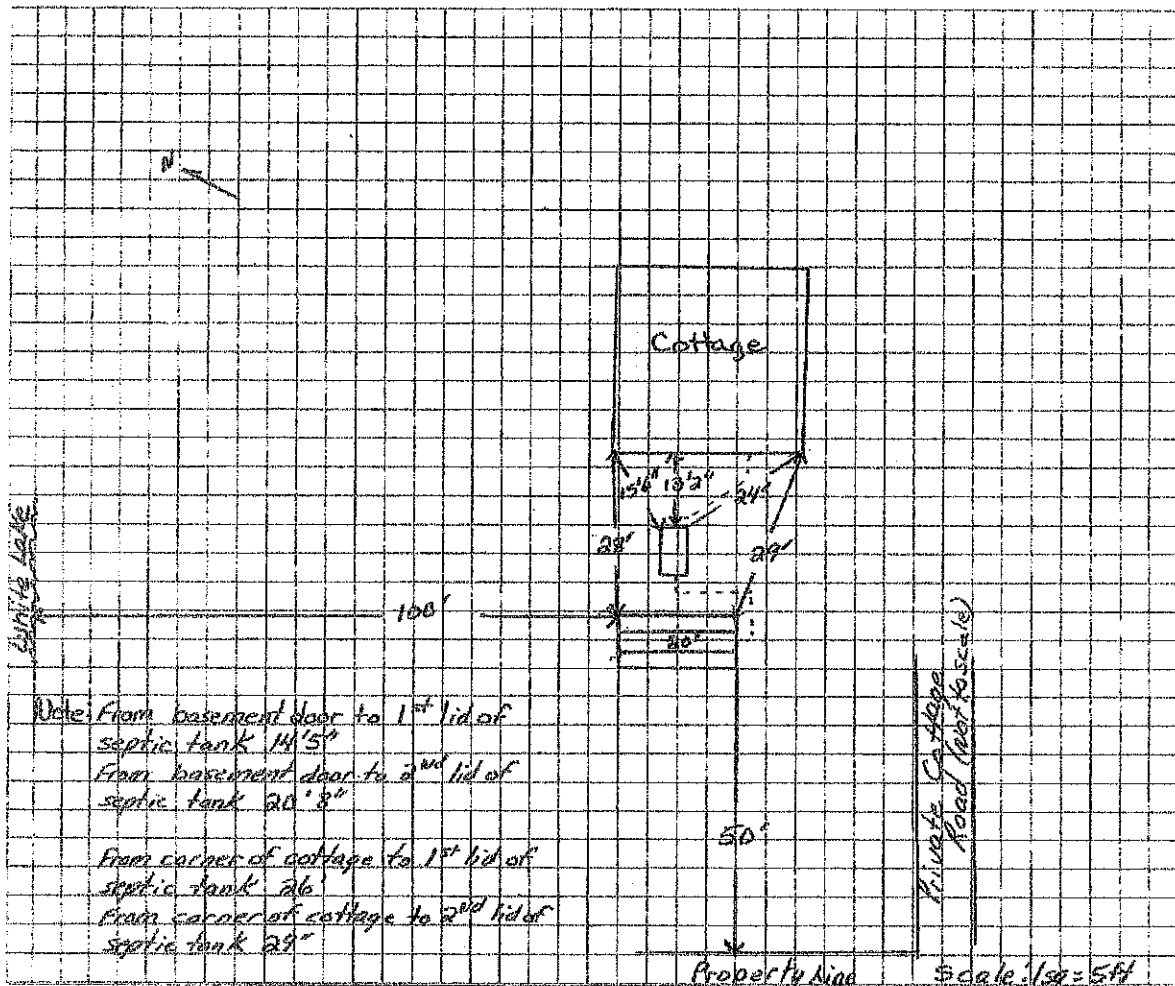
### 2. Location

- System components installed as shown on application to install a Class 4,5 Sewage System ☐
- If located other than in (a) use space below for sketch and dimensions from permanent points of reference sufficient to facilitate future location of tank and leaching bed including orientation of pipe runs.
